Facility Name: Washington Beef, LLC

Purpose: Determination of compliance with the Clean Water Act

Inspection Date: September 2, 2009

**Photograph Documentation
Washington Beef, LLC
(September 2, 2009 Inspection)**

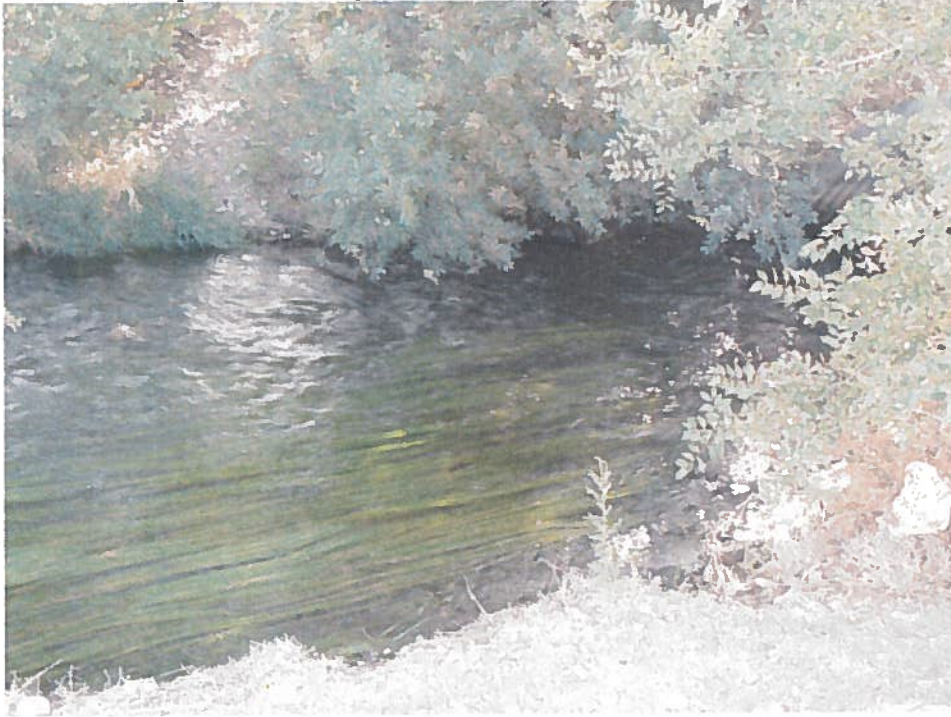
Photo 1 – Photo shows the Wanity Slough upstream of the facility. Notice the Slough appears to be much clearer than the downstream photo in Photo 2. This is consistent with my observations at the time of the inspection.

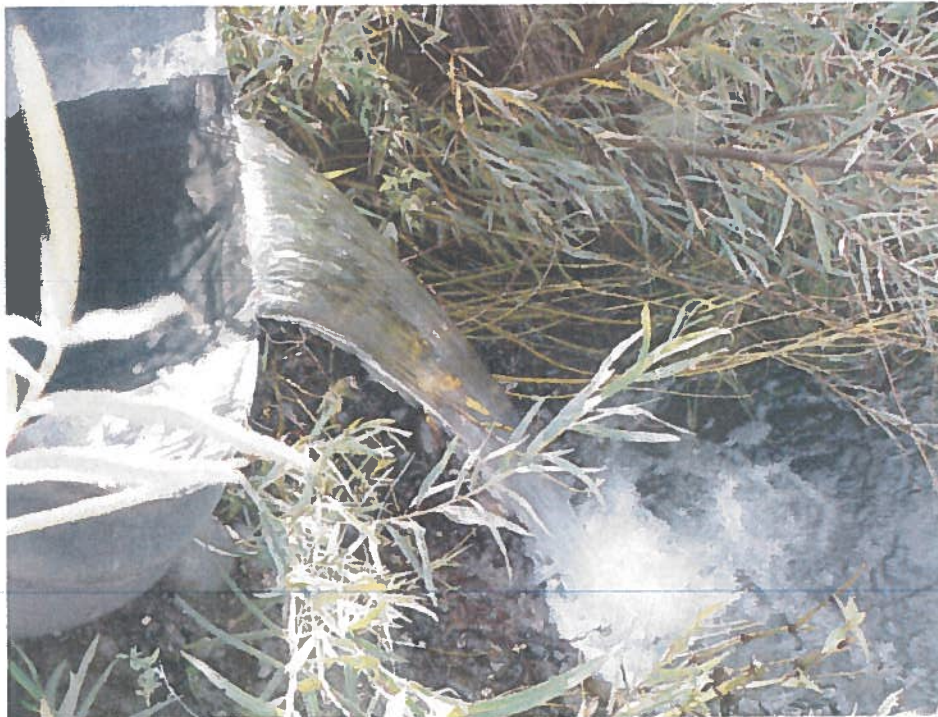
Photo 2 – Photo of the Spencer Lateral as it enters the Wanity Slough. Note the clarity of the water. Spencer Lateral enters Wanity Slough downstream of Outfall 002 discharges

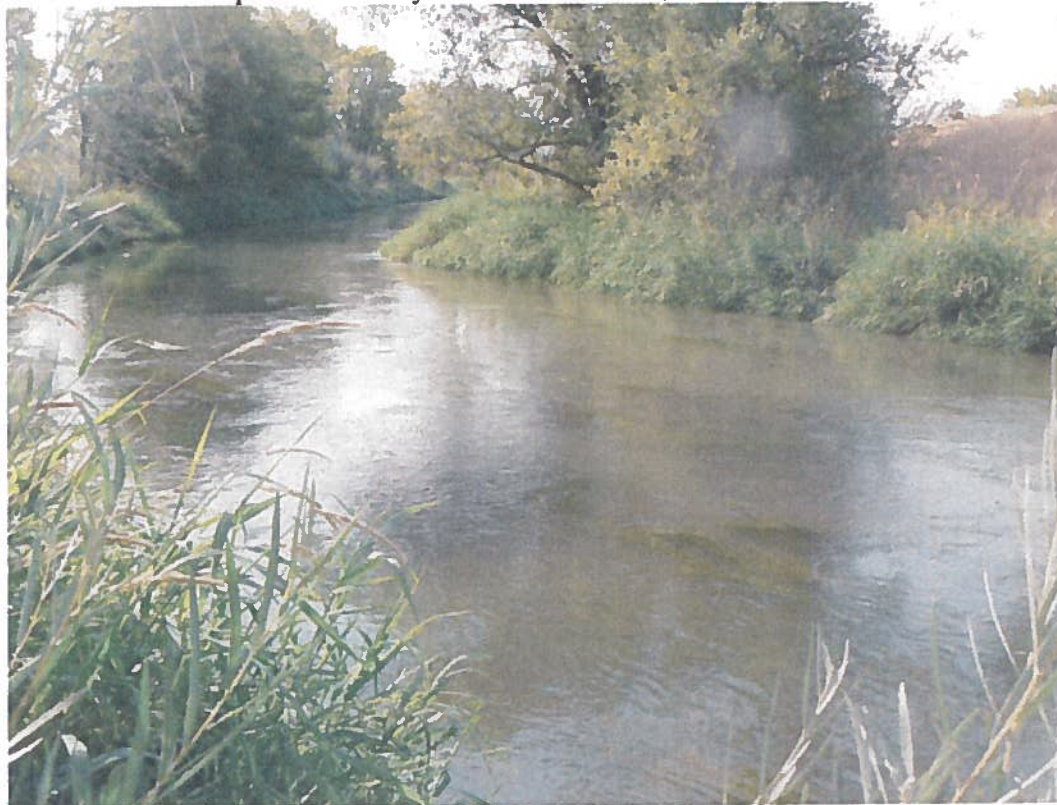
During the inspection I observed the discharge going to the Wanity Slough. The discharge was very turbid.

Photo 3 – Photo shows Wanity Slough (taken just downstream of Photo 2). Note that the Slough appears to be very turbid. This point is downstream of Outfall 002 discharges.
